PETRONAS Water Technology Users Forum 2003

Non-Chemical Scale Control of Water Process Systems

**Presented at the Petronas Water Technology Users Forum 2003
11 – 12 March 2003, MS Garden Hotel, Kuantan, Malaysia**

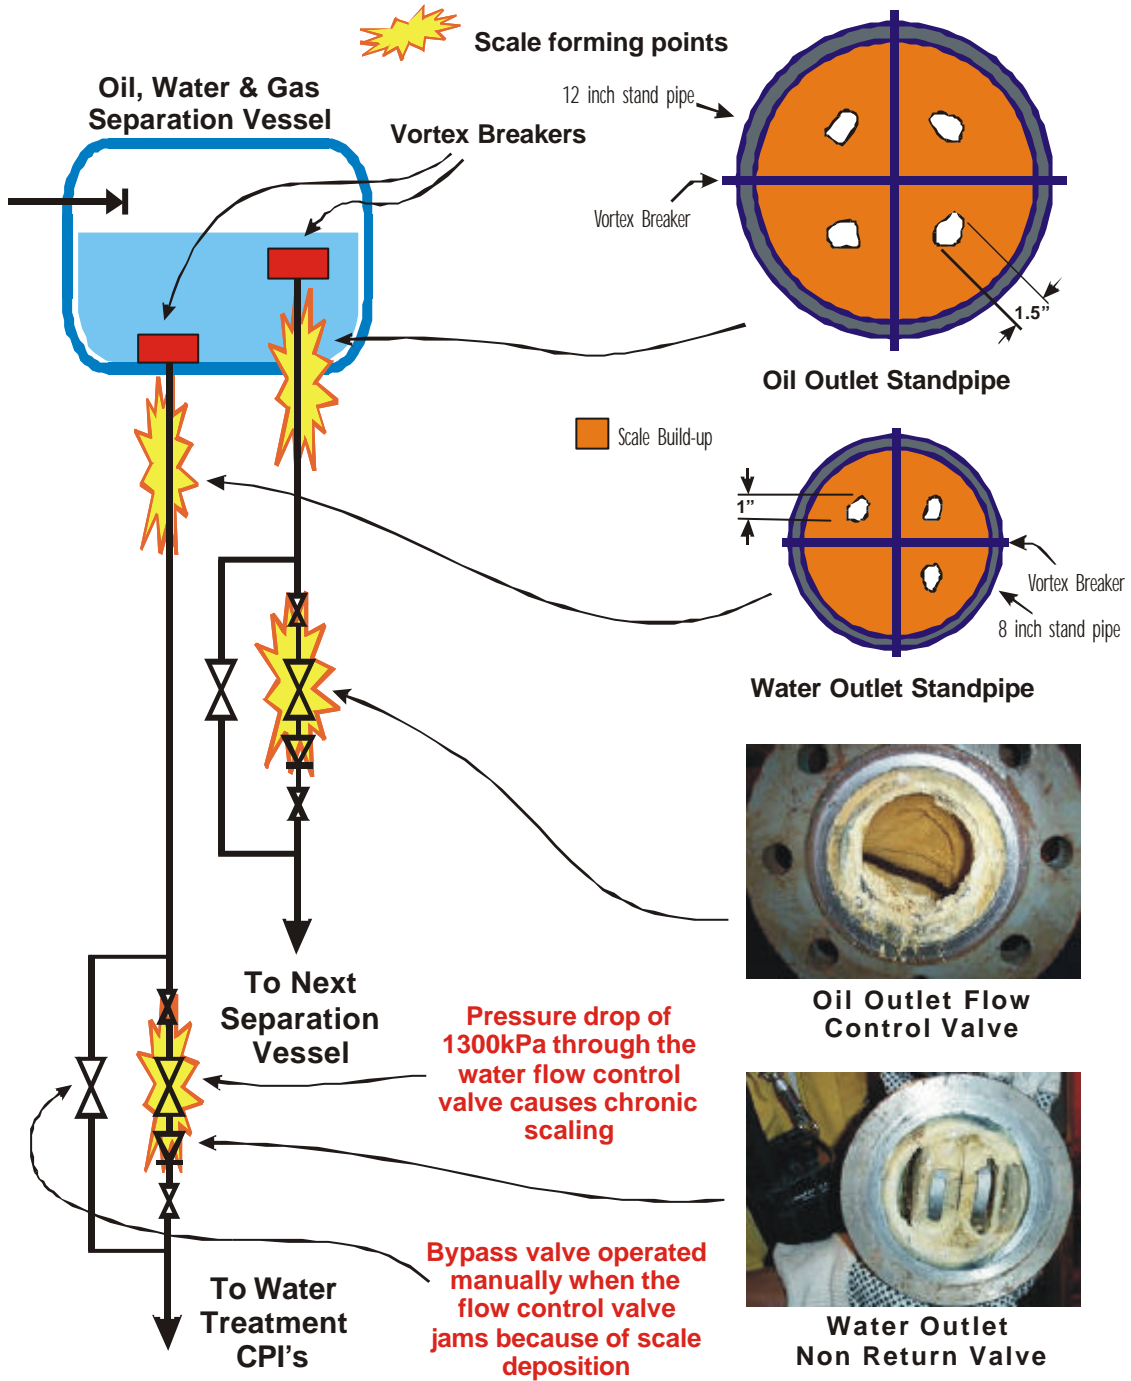
**Oil/Water/Gas Separation Vessel
Oil and Water Standpipes and Control Valves
Scale Build Up Before Descaling
At 3 Monthly Platform Shutdown
Before Installation of MFC's**

The platform had to be shutdown every 3 months for de-scaling. Appendix B graphically shows the scale problem in the standpipes and valves. The types of scale were 95% calcite, 3% dolomite and 2% barite.

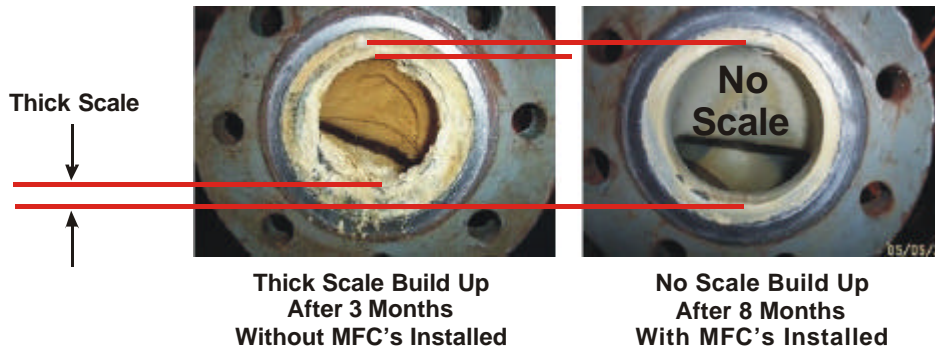
Oil Control Valve

Scale Build Up Before and 8 Months After Installation of Scale-X™ MFC's

Photographs taken before descaling at 3 monthly platform shutdown before installation of Scale-X MFC's

Photographs taken during the general field shutdown 8 months after installation of the Scale-X MFC's

In May 2002, 8 months after installation of the MFC's, there was a general field shutdown which allowed an internal visual inspection of the separation vessel, valves and pipes to be carried out. Photographs from that inspection are contained in Appendix C and visually shows that new scale formation had been eliminated.

Appendix C photographs show the scale build ups after 3 months without the MFC's and no scale build-up at 8 months with the MFC's installed. (The photographs at 8 months were taken during the general field shutdown.) Appendices E and F show the stabilised operational performance of the platform system in maintaining full production output with the control valves remaining fully operational.

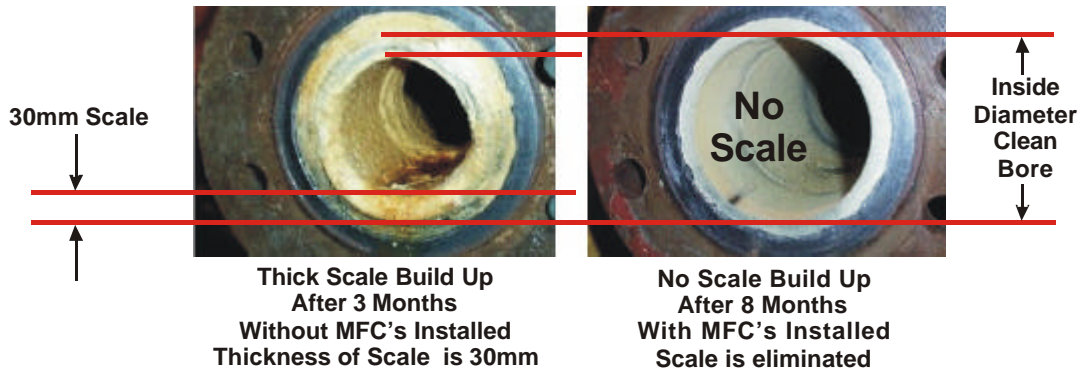
Block Valve Reducer Downstream of Oil Control Valve

NOTE: The liquid through these valves and reducer is 3 parts crude oil and 1 part formation water.

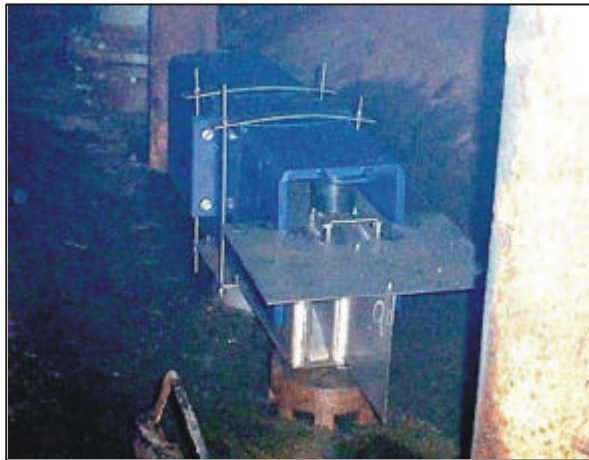
Appendix D

Scale-X™ MFC Installed on the Separation Vessel Water Outlet Standpipe

Specially designed "application specific" Scale-X™ MFC's were installed internal to the separation vessel on the standpipes and replaced the vortex breakers. These MFC's incorporated vortex breaker duties and a photograph of the MFC on the water outlet standpipe is shown in Appendix D.

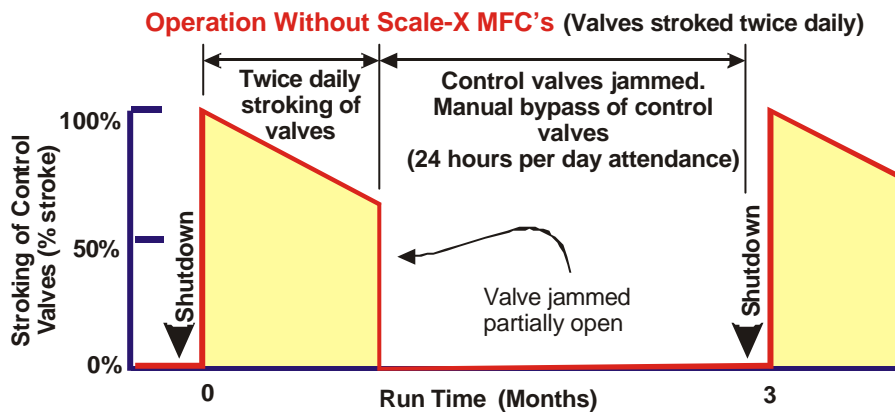
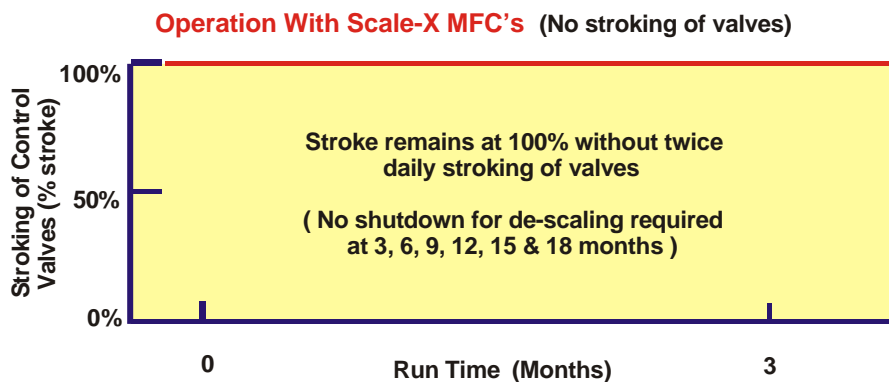
Appendix E

Stroking of Flow Control Valves
Oil & Water Separation Vessel Control Valves
Without and With Scale-X MFC's

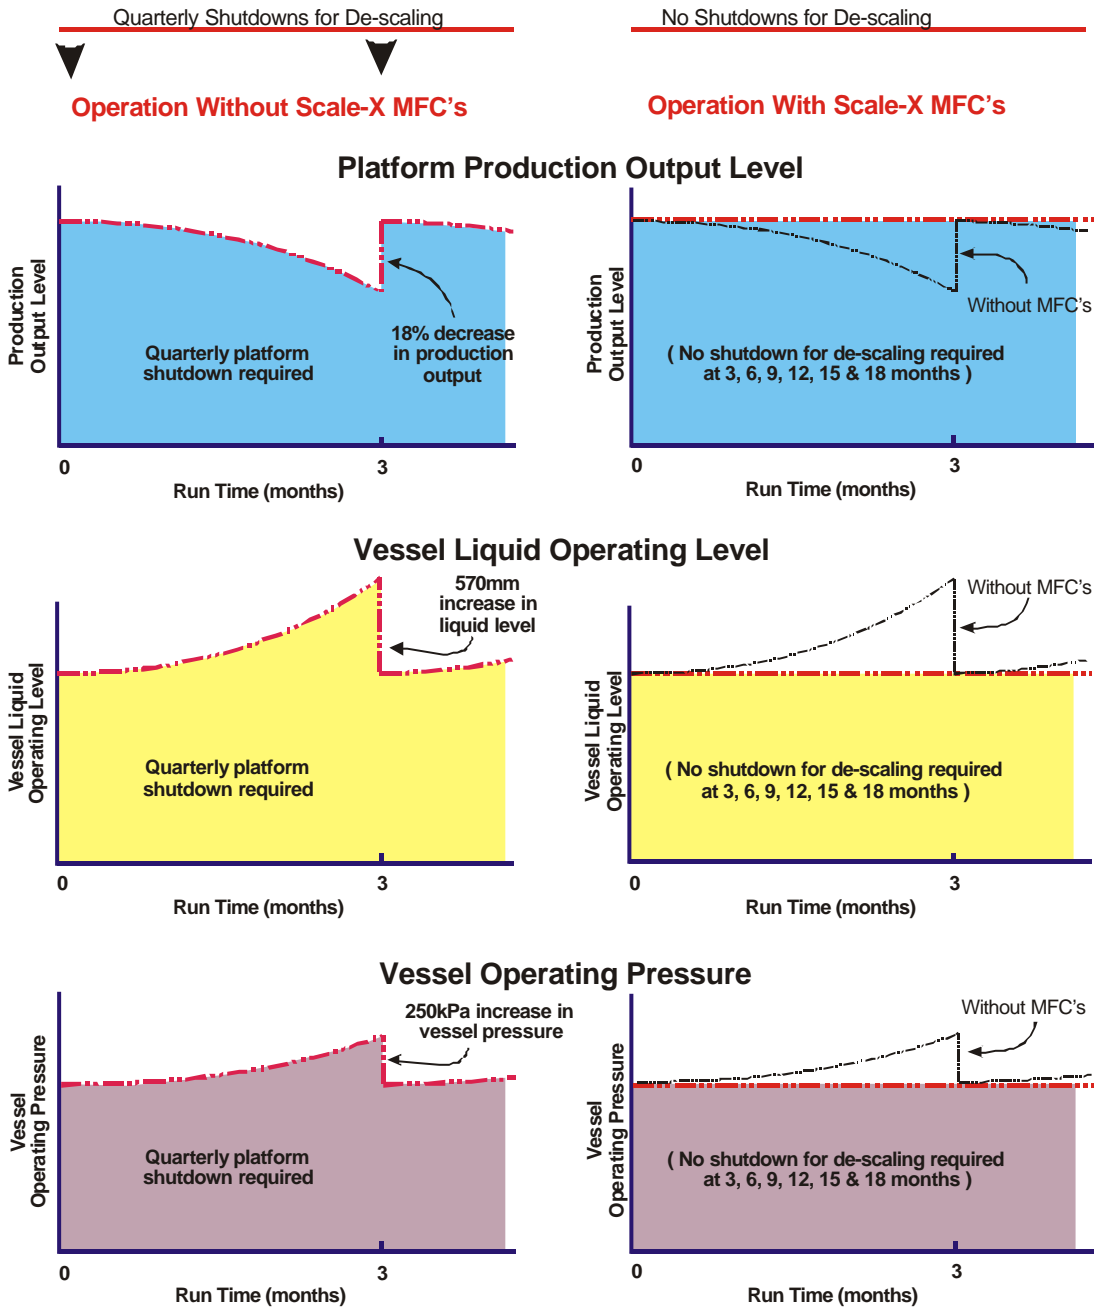
Appendix F

Platform Operational Parameters
Production Output, Vessel Liquid Level & Vessel Pressure
South China Sea, Tinggi Field Offshore Oil Platform
Without and With Scale-X MFC's
