9th APCChE Congress

Chemeca 2002

## Magnetic Fluid Conditioners Eliminate Severe Scale Problem on South China Sea Offshore Oil Platform

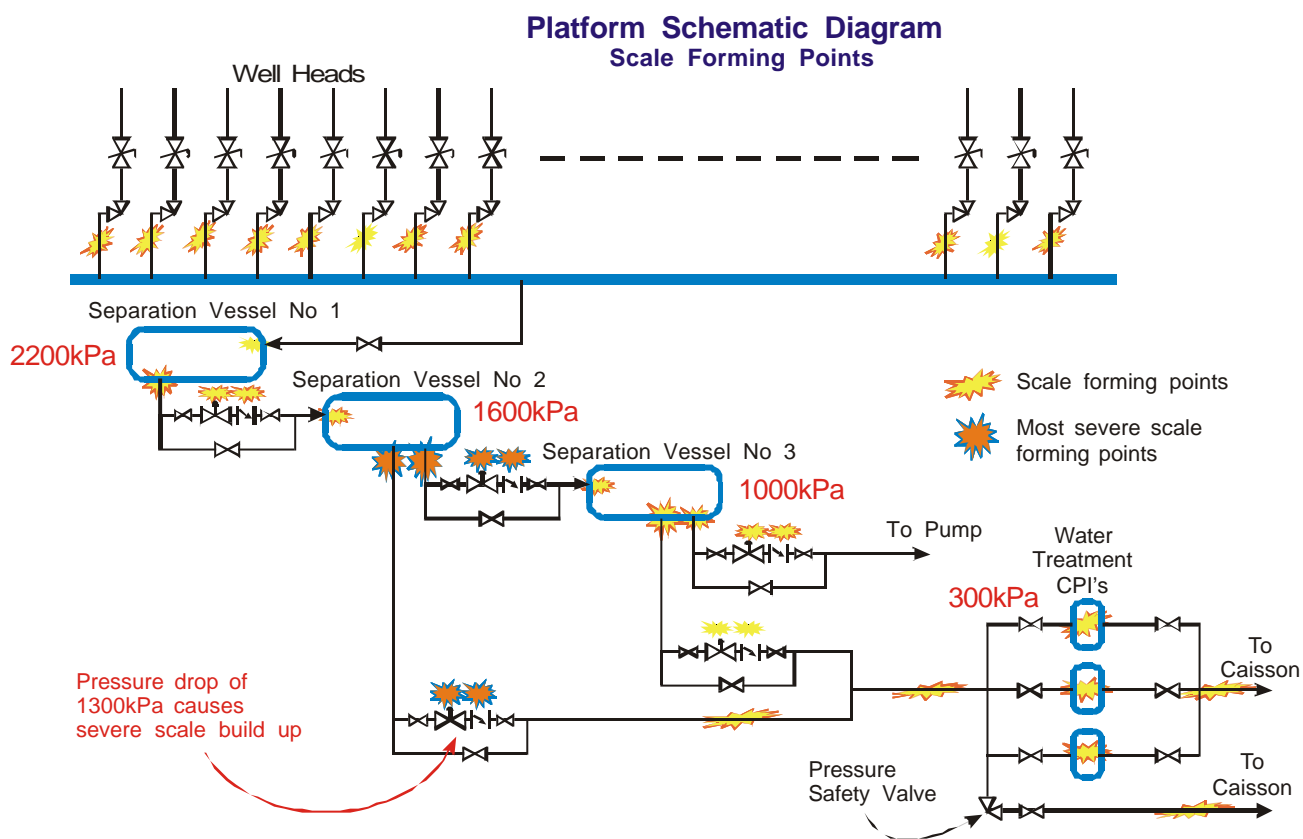
Diagram No.1A

This platform has a high water cut and the severe scale problem is caused by the scaling properties of the formation water. At each pressure reduction point in the process CO<sub>2</sub> is released, this affects the solubility of CaCO<sub>3</sub> causing it to precipitate as scale. Scale build up occurs in pipes after the well head choke valves, in the vessel outlet stand pipes, in the control valves and non-return valves and in the pipes particularly those pipes before and after the corrugated plate interceptors. The locations of these scaling points are shown in schematic Diagram No. 1A.

The most severe scale problem on the platform was at the second stage separation vessel (that is, the first oil/water separation vessel) as shown in Diagram No. 1A. This vessel has 3 phase separation, gas/oil/water, and the worst situation for scaling because of the large amount of gas liberated. At each point of pressure reduction gas is liberated, not only at valves but even over pipe fittings and vessel nozzles (entrées and exits and vortex separators). Gas release is a main component in the chemistry of scale production.

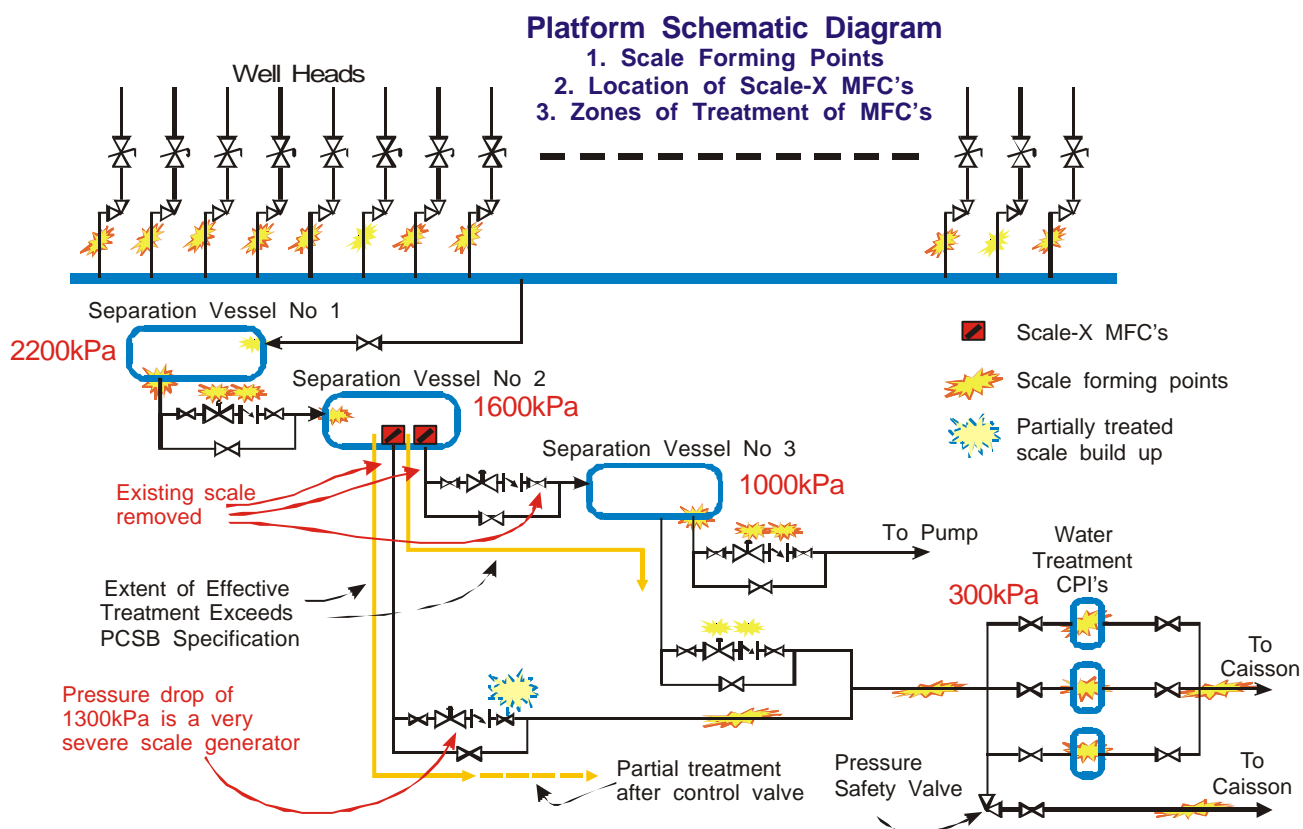
Diagram No.1B

The heavy build ups of scale formed in the water and oil stand pipes and their vortex breakers and the oil and water flow control valves and non-return valves are shown in Diagram No. 1A. **Note:** at this point in the oil/water separation system the liquid in the oil line is 3 parts crude and 1 part formation water. Scale had virtually plugged the 8inch water outlet, growing inwards in rings of white scale and gray to brown oil and oxide deposits. The vortex breaker baffles were heavily encrusted, particularly in areas of high fluid turbulence.

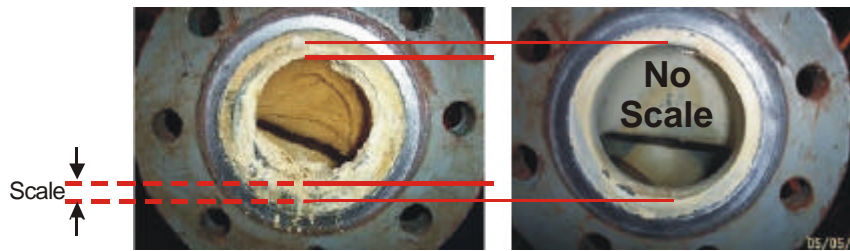
Diagram No.2

**Oil Control Valve**

Thick Scale Build Up  
After 3 Months  
Without MFC's Installed

No Scale Build Up  
After 8 Months  
With MFC's Installed

Diagram No. 2 show photographs of the oil control valve, non return valve and block valve reducer down stream of the control valve at 3 months without MFC's installed and at 8 months with MFC's installed. These graphically demonstrate how the MFC's have totally eliminated the severe scale build up.

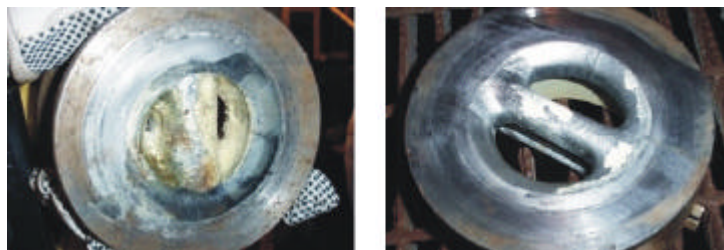
**Non-Return Valve**

Heavy Scale Build Up  
After 3 Months  
Without MFC's Installed

No Scale Build Up  
After 8 Months  
With MFC's Installed

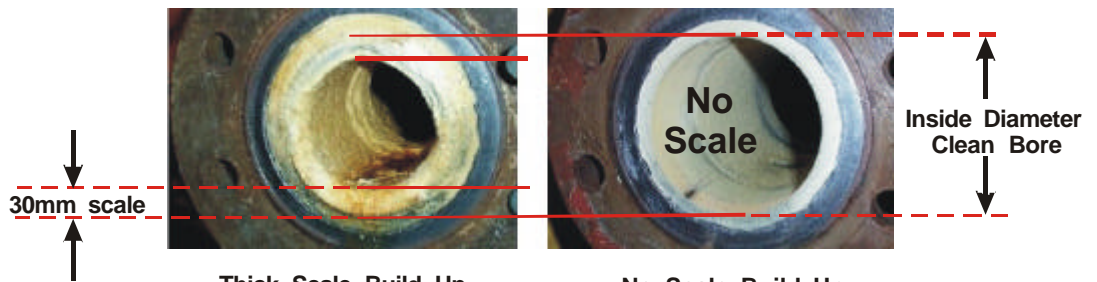
**Block Valve Reducer Downstream  
of Oil Control Valve**

Thick Scale Build Up  
After 3 Months  
Without MFC's Installed  
Thickness of Scale is 30mm

No Scale Build Up  
After 8 Months  
With MFC's Installed  
Scale is eliminated

**NOTE: The liquid through these valves and reducer is 3 parts crude oil and 1 part formation water.**

2. **Existing Scale Removed:** The MFC's have removed pre-existing scale in the stand pipes and the pipes downstream of the oil control valve which was not removed during the shutdown de-scaling carried out before installation of the MFC's. The down stream block valve and pipes are now free of scale.

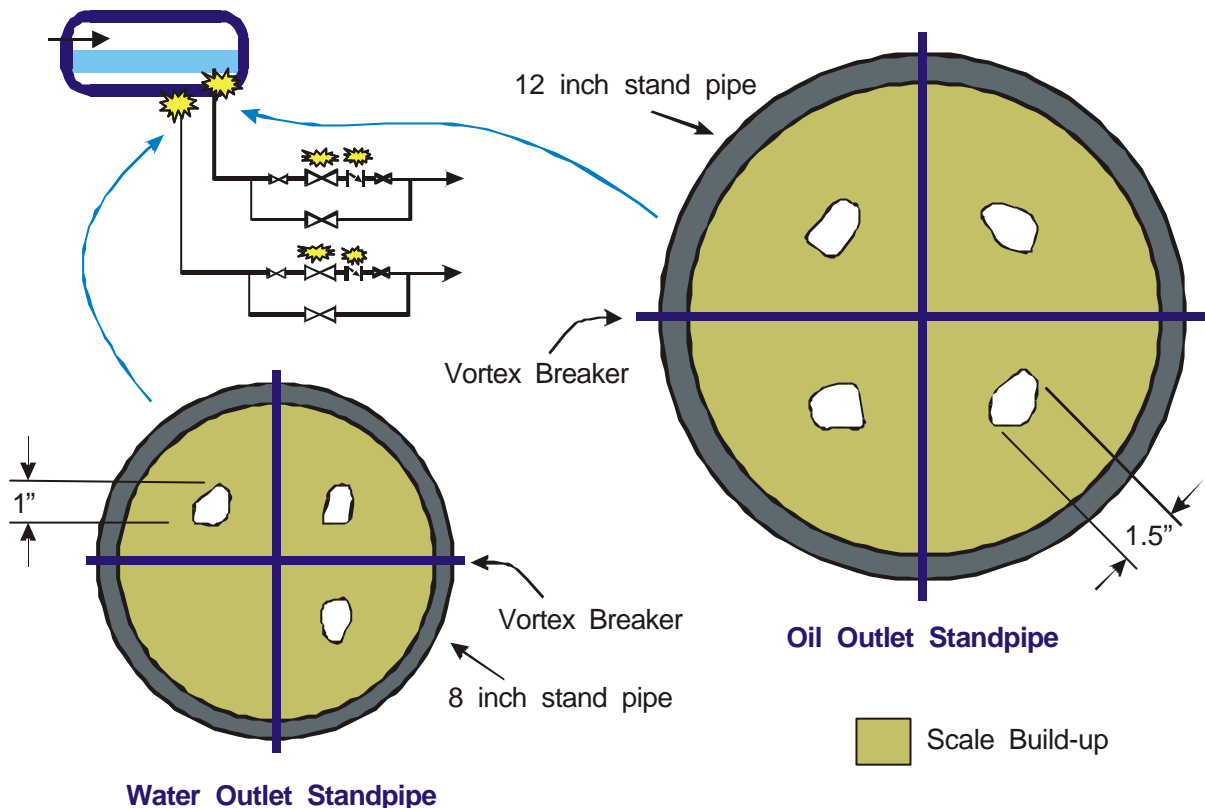
Diagram No.3

**Oil/Water/Gas Separation Vessel  
Oil and Water Standpipes  
Scale Build Up Before De-scaling  
Without MFC's Installed**

A sketch detailing the extent of the scale build up in the standpipes before de-scaling is shown in Diagram No. 3.

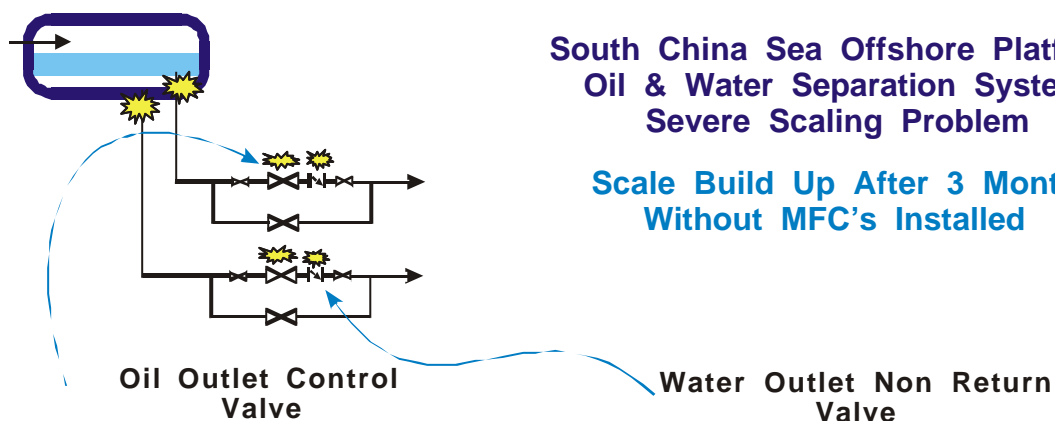
Diagram No.4

**South China Sea Offshore Platform  
Oil & Water Separation System  
Severe Scaling Problem**

**Scale Build Up After 3 Months  
Without MFC's Installed**

Photographs (refer Diagram No. 4), showing the scale build up in the oil outlet control valve and the water outlet non-return valve gives an indication of the severity of the scale problem. The control valves became stuck (inoperative) within 4 to 6 weeks after the platform de-scaling shutdown, even though they were stroked twice daily to mechanically remove the scale and chemical scale inhibitors were used. (**Note:** the control valves became stuck within 15 days when scale inhibitors were not used.) An operator was then stationed 24 hours per day at the bypass valves of the flow control valves to manually control liquid levels in the separator vessel.

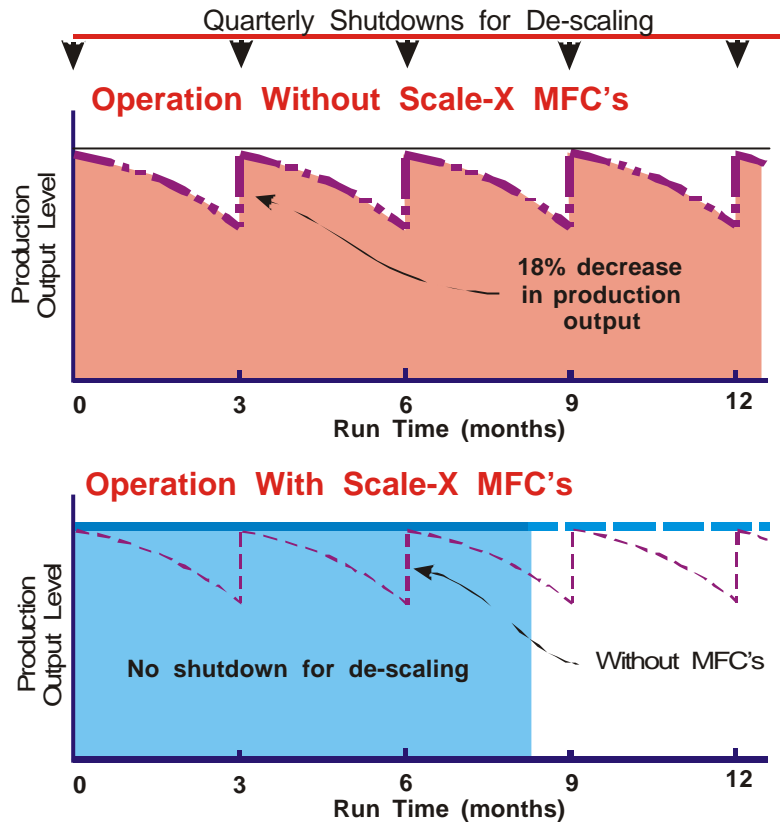
Diagram No.5A

**Production Output Level  
Operation of South China Sea Offshore Oil Platform  
Without and With Scale-X MFC's**

7. **100% Production Output Level Maintained:** There has been no drop off in production output level, that is, the production has remained at 100% since installation of the MFC's. Before installation of the MFC's, the production level dropped off by 18% over the three months between shutdowns.

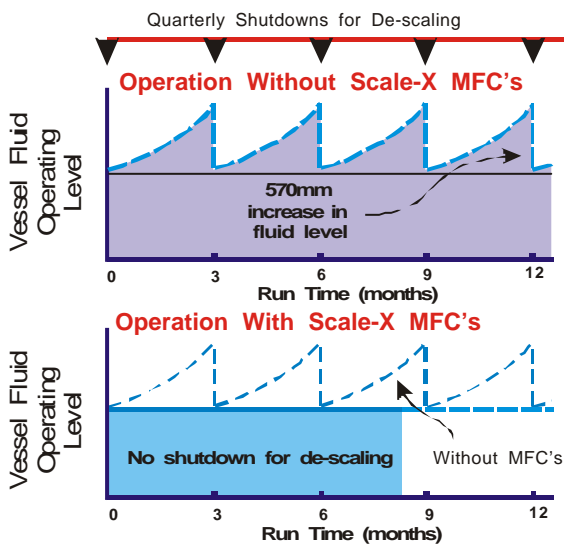
Diagram No.5B

**Vessel Operating Liquid Level  
Operation of South China Sea Offshore Oil Platform  
Oil & Water Separation Vessel  
Without and With Scale-X MFC's**

5. **Vessel Liquid Level Unchanged:** The liquid level in the vessel had not been raised. Before installation of the MFC's it had to be ramped up 570mm over the 3 months to try to maintain production output.

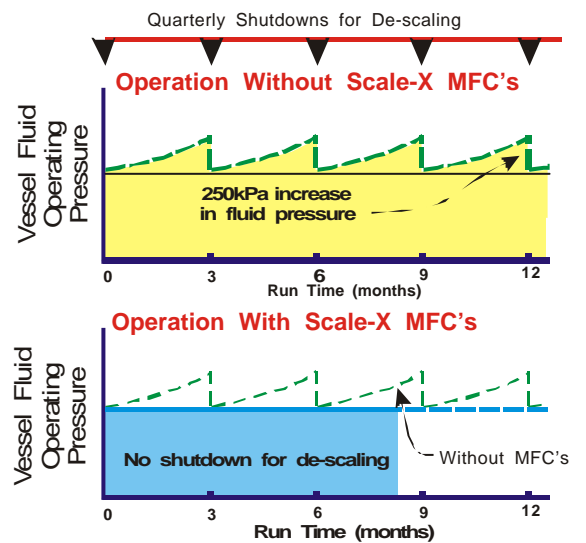
Diagram No.5C

**Vessel Operating Pressure  
Operation of South China Sea Offshore Oil Platform  
Oil & Water Separation Vessel  
Without and With Scale-X MFC's**

6. **Vessel Pressure Unchanged:** The vessel pressure had not needed to be increased. Before installation of the MFC's the pressure was ramped up 250kPa over the 3 month period between shutdowns.

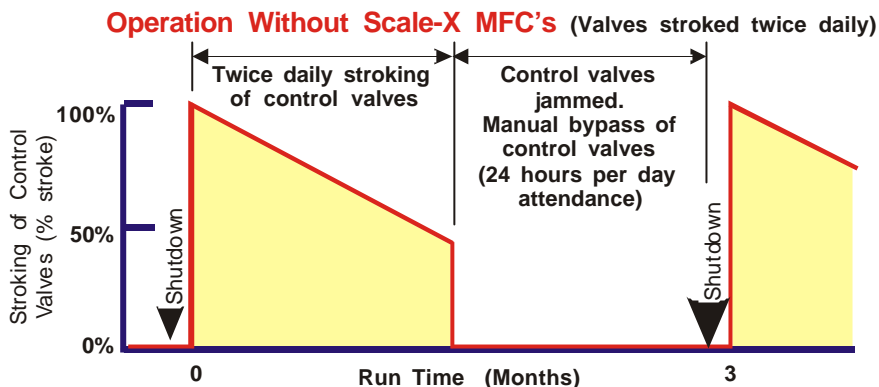
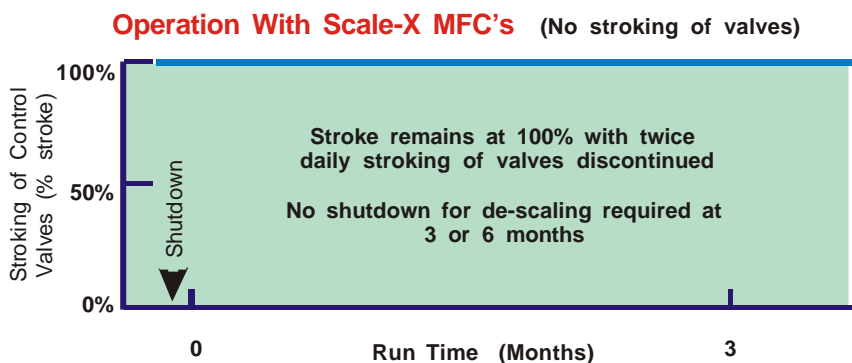
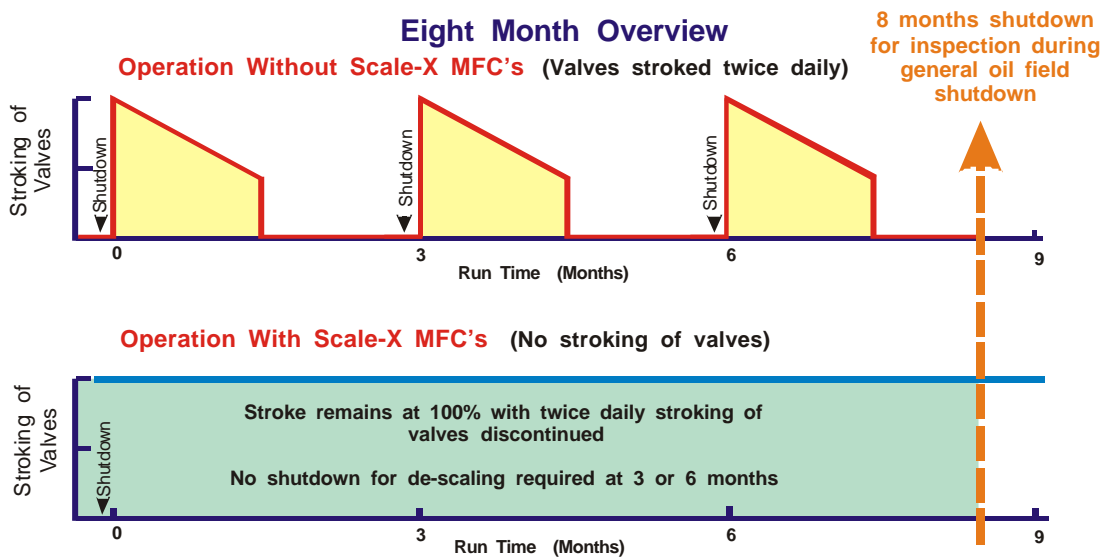
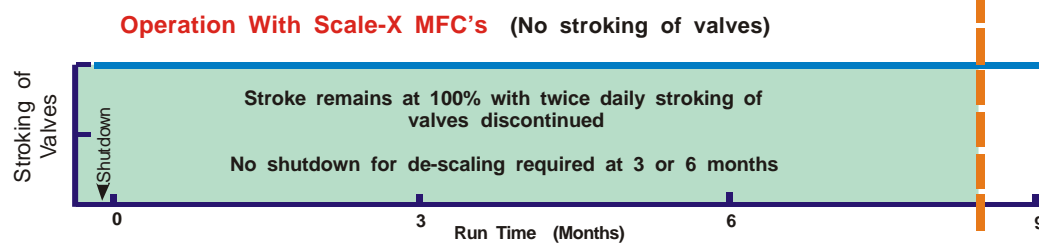
Diagram No.6

**Stroking of Flow Control Valves  
Oil & Water Separation Vessel Control Valves  
Without and With Scale-X MFC's**

**Eight Month Overview**

Before installation of the MFC's, over the three months between shutdowns for de-scaling, the separation vessel pressure was progressively ramped-up a total of 250kPa and the liquid level was raised by a total of 570mm. Even with these operational changes the production output dropped off by 18% over the 3 months between scheduled de-scaling shutdowns. These operational changes are shown in Diagram Nos. 5A, 5B and 5C and the progressive reduction in valve stroke as the valves scale up is shown in Diagram No. 6. It is

3. **100% Stroking of Valves:** The oil and water outlet control valves no longer required to be stroked and remained 100% operational, that is, there had been no reduction in the stroke of the valves. These valves had previously been manually operated (stroked) twice daily in an attempt to mechanically remove scale and keep the valves operational.

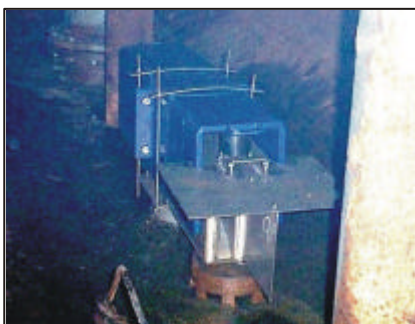
Diagram No.7

**Scale-X™ MFC  
Installed on the  
Separation Vessel  
Water Outlet Standpipe**

Two prototype Scale-X™ MFC's were developed and manufactured for installation on the oil and water stand pipes of the separation vessel, that is, to treat the most severe scaling problem on the platform. These units were installed in the August 2001 scheduled platform de-scaling shutdown at the points shown in Diagram No. 1B. The vortex breakers were removed and replaced by the MFC's. A photograph of the Scale-X™ MFC installed on the water outlet standpipe is shown in Diagram No. 7.

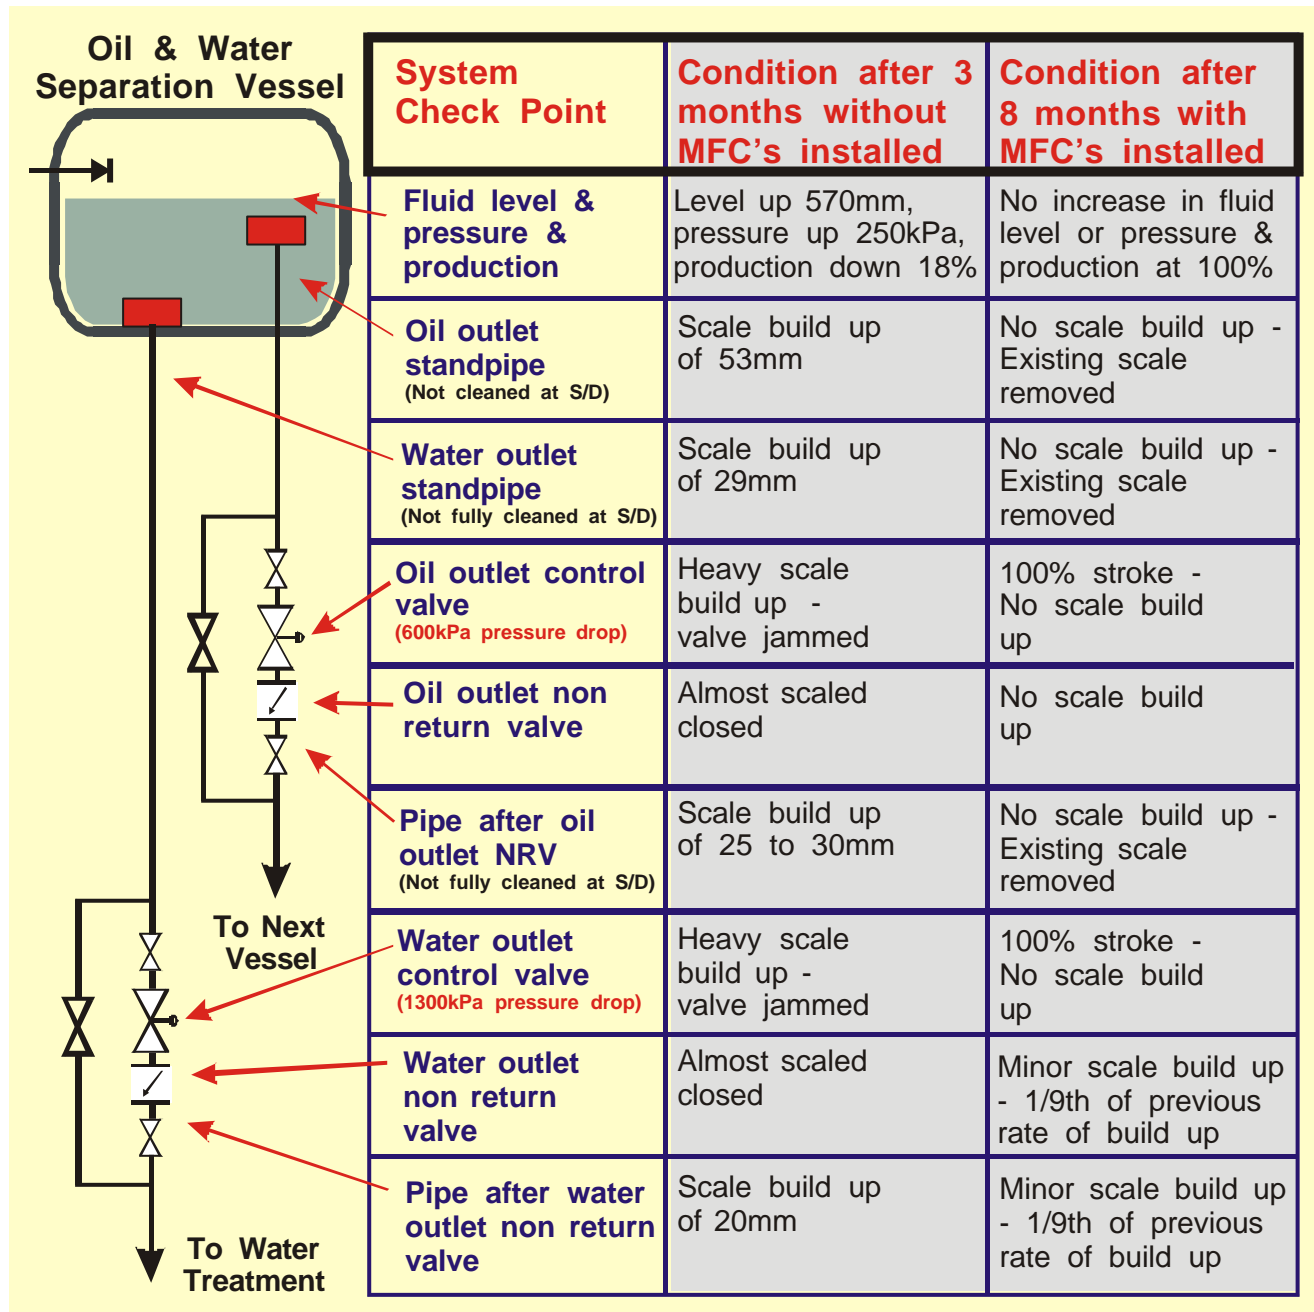
Diagram No.8

## Condition of Standpipes, Valves and Pipes Before and After Installation of Scale-X MFC's on Offshore Oil Platform

A summary of the benefits arising from the installation of the MFC's is given in Diagram No. 8.
