9th APCChE Congress

Chemeca 2002

## Magnetic Fluid Conditioners Eliminate Severe Scale Problem on South China Sea Offshore Oil Platform

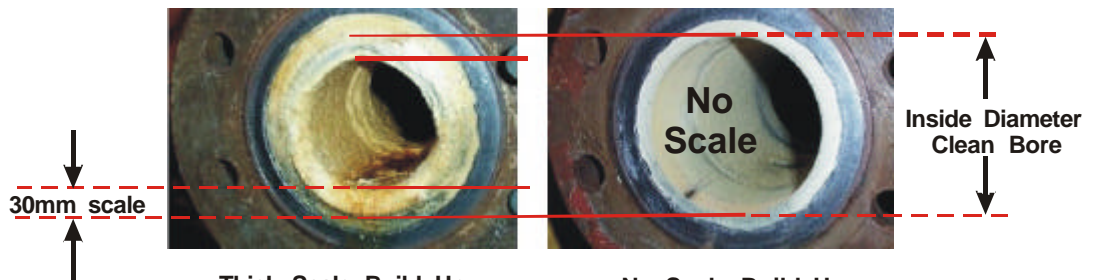
**Block Valve Reducer Downstream  
of Oil Control Valve**

Thick Scale Build Up  
After 3 Months  
Without MFC's Installed  
Thickness of Scale is 30mm

No Scale Build Up  
After 8 Months  
With MFC's Installed  
Scale is eliminated

Diagram No. 2 show photographs of the oil control valve, non return valve and block valve reducer down stream of the control valve at 3 months without MFC's installed and at 8 months with MFC's installed. These graphically demonstrate how the MFC's have totally eliminated the severe scale build up.

**NOTE: The liquid through these valves and reducer is 3 parts crude oil and 1 part formation water.**

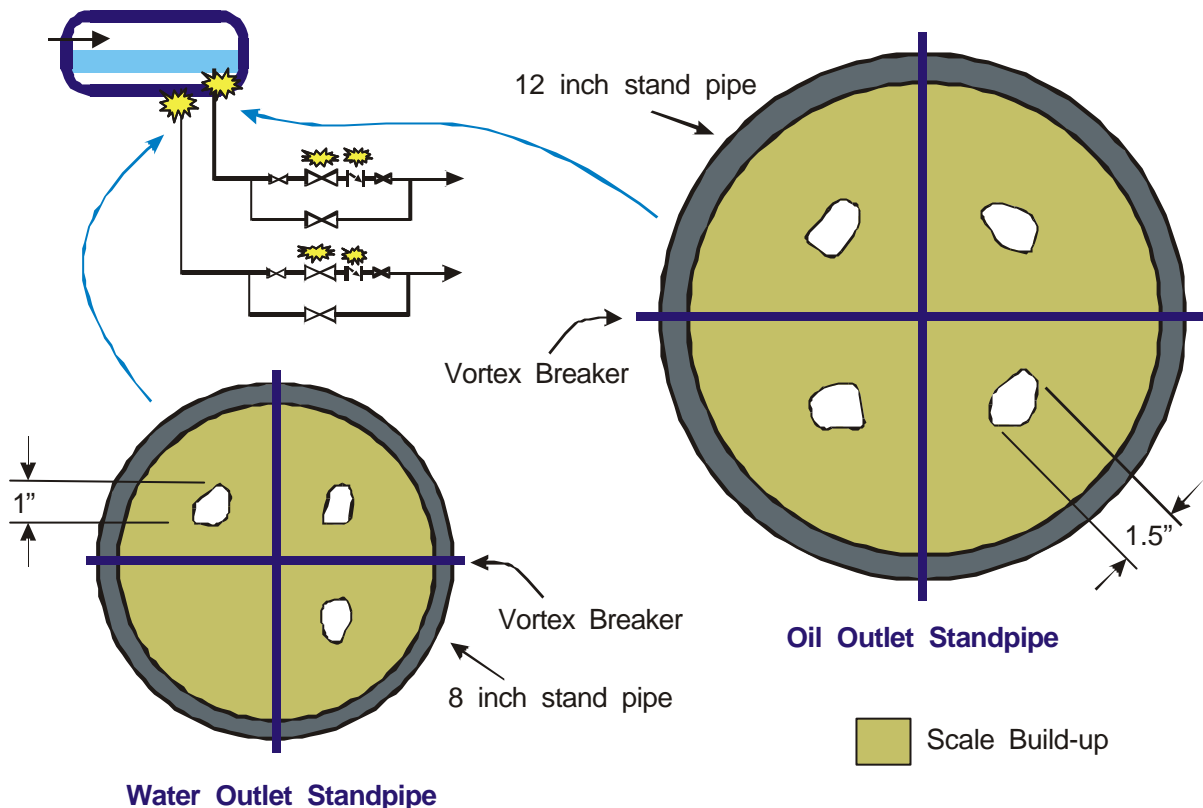
Diagram No.3

**Oil/Water/Gas Separation Vessel  
Oil and Water Standpipes  
Scale Build Up Before De-scaling  
Without MFC's Installed**

A sketch detailing the extent of the scale build up in the standpipes before de-scaling is shown in Diagram No. 3.

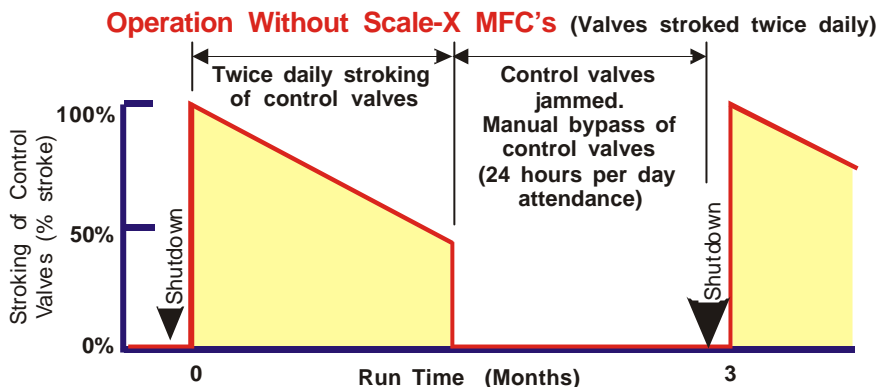
Diagram No.6

**Stroking of Flow Control Valves  
Oil & Water Separation Vessel Control Valves  
Without and With Scale-X MFC's**

**Eight Month Overview**

Before installation of the MFC's, over the three months between shutdowns for de-scaling, the separation vessel pressure was progressively ramped-up a total of 250kPa and the liquid level was raised by a total of 570mm. Even with these operational changes the production output dropped off by 18% over the 3 months between scheduled de-scaling shutdowns. These operational changes are shown in Diagram Nos. 5A, 5B and 5C and the progressive reduction in valve stroke as the valves scale up is shown in Diagram No. 6. It is

3. **100% Stroking of Valves:** The oil and water outlet control valves no longer required to be stroked and remained 100% operational, that is, there had been no reduction in the stroke of the valves. These valves had previously been manually operated (stroked) twice daily in an attempt to mechanically remove scale and keep the valves operational.
